Tech Tip

NOISE AND VIBRATION 179

TROUBLESHOOTING NOISE AND VIBRATION

Pinpointing the Source Can Be Elusive

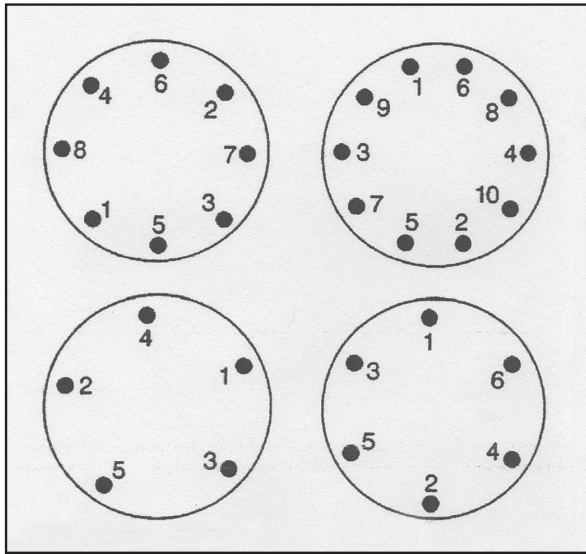
GM Promotes Wheel Torque to Correct Vibrations: Lug nut torque is the usual description that we apply to wheel torque. We found a recent GM bulletin concerning lug nut torque to be very interesting, as most associate uneven lug nut torque with rotor warpage and pedal pulsation while braking. The symptoms can involve much more. Improper lug nut torque procedures can result in the wheel and tire assembly being off-set during mounting. The off-set causes the mass of the tire and wheel assembly to orbit the axis of the hub, creating a vibration similar to a tire not properly balanced or one with excessive RFV. The improper torque can cause a distortion of the brake rotor, resulting in a variance in wheel mounting that can cause a condition referred to as smooth road shake vibration.

Wheel Installation Procedure: GM recommends the following installation procedure. For vibration symptoms, remove the tire and wheel assembly and index at least two stud positions from the previous mounted position. Tighten the lug nuts using a 3-step procedure. DO NOT use torque sticks or an air impact wrench to tighten the lug nuts.

- 1) Install lug nuts and hand tighten using only a socket.
- 2) Snug all lug nuts using a star pattern with a hand wrench (see illustration on next page).
- 3) Lower vehicle enough to provide wheel resistance and torque to specification with a torque wrench.

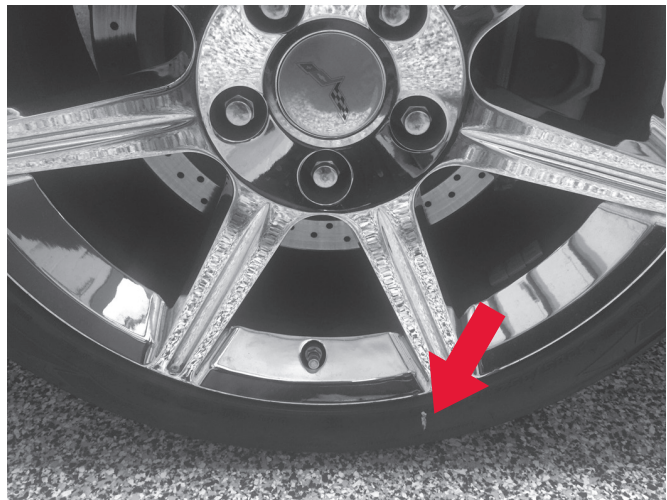
Slippage of a tire on the wheel following a tire replacement results in an imbalance and vibration symptoms.

The condition is usually the result of improper or excessively used non-preferred lubricants that do not dry sufficiently, making the tire and rim excessively slippery. Some lubricants require up to 24 hours to completely dry and the tires achieve maximum adherence to the rims. GM cautions not to use products containing silicone, alcohol, petroleum based products, solvents or corrosives for cleaning or lubrication.

To determine if slippage has occurred, make it a habit to place a chalk mark on the tire directly in line with the valve stem following the tire replacement. Any slippage will be immediately recognizable. Tire movement exceeding one inch can promote a vibration. The tire and wheel illustrated (see illustration) has moved beyond the one inch limit of travel promoting an imbalance condition. This explains why a vehicle may leave your shop with perfectly balanced wheels and tires and then return with an imbalance condition.
