## CHEVROLET COLORADO and GMC CANYON The Challenge of an Oil Filter Replacement

LARRY HAMMER, Technical Services  
Mighty Distributing System of America

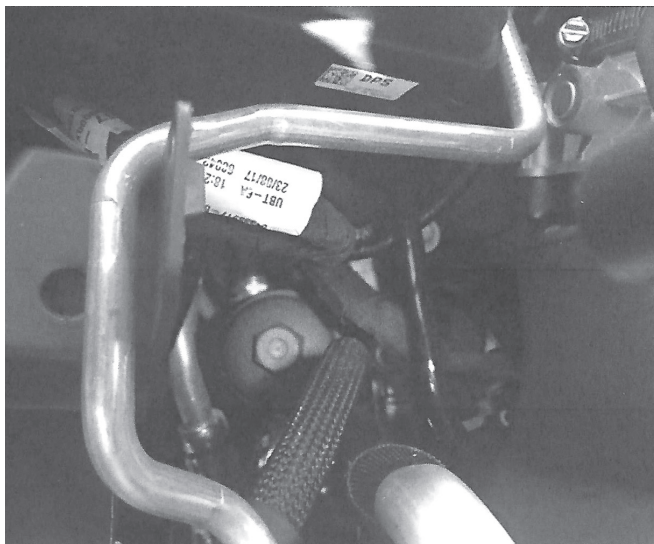
Fig. 1

The difficulty is preventing damage to the standpipe in the filter housing when removing and installing the oil filter. The filter cap has a web of hoses, wiring harness, plus an AC line directly overhead, making it difficult to remove

the filter without some careful maneuvering and flexing of the filter, standpipe and cap (see Fig.1). Some technicians recommend changing the filter from beneath the vehicle. Whichever method you use, take extreme caution to prevent damage to the standpipe.

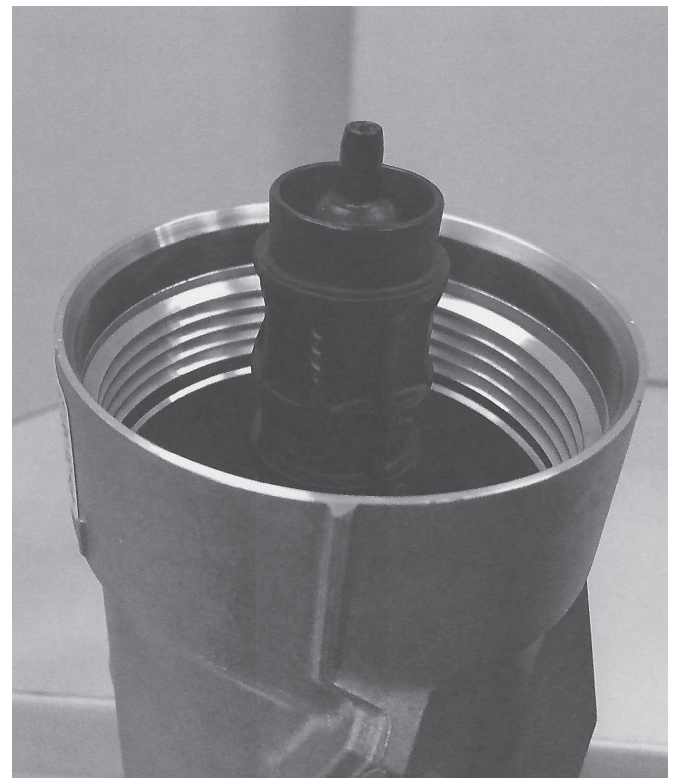
Fig. 2

The standpipe has a two part function. It contains a filter bypass assembly to ensure continued lubricant flow in the event of a filter restriction, and it prevents the filter from collapsing under pressure from the oil pump (see Fig. 2).

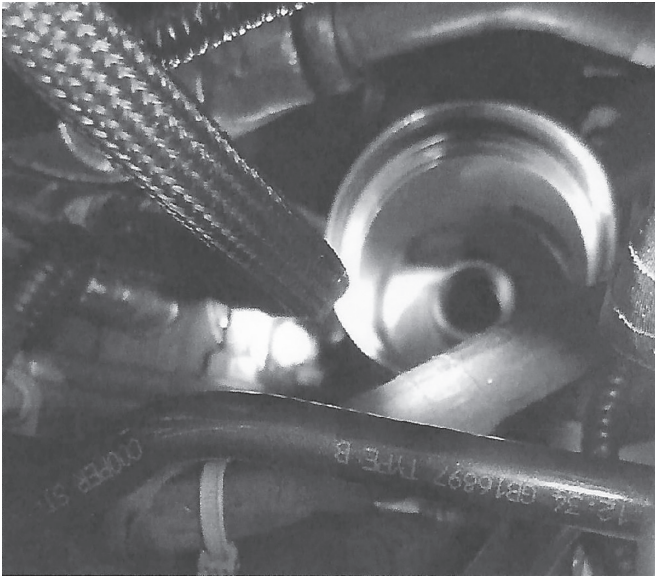
**Fig. 3**

The industry has encountered engine claims due to the standpipe being dislodged or separated from the housing when performing a filter replacement (see Fig.3). Often, the damage goes unnoticed by the lube tech. Installing a replacement filter without the standpipe secured in the filter housing can result in a collapsed filter (see Fig.4), thereby restricting oil flow, resulting in a catastrophic engine failure.

is a part of the bypass valve assembly. When the standpipe is dislodged, the installation of a new filter housing will be necessary, as the standpipe is not a replacement item. GM has a revised housing P/N 12682014 for the mentioned applications.
