Tech Tip

HUB BEARINGS 178

HUB BEARINGS AND SENSORS When They Fail the Symptoms Can Be Elusive

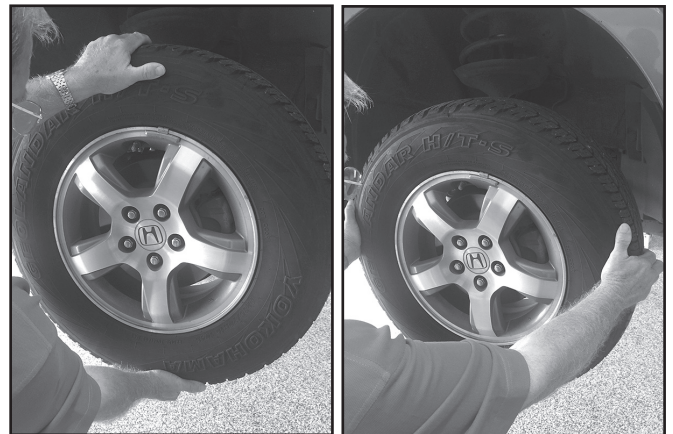
- 1) With the vehicle safely supported on a lift or jack stands, grasp the tire and wheel at 12:00 and 6:00 o'clock position (see illustration) and check for looseness. Repeat the same procedure with the hands positioned at 3:00 and 9:00 o'clock position. Having a helper observe the source of any movement is recommended.

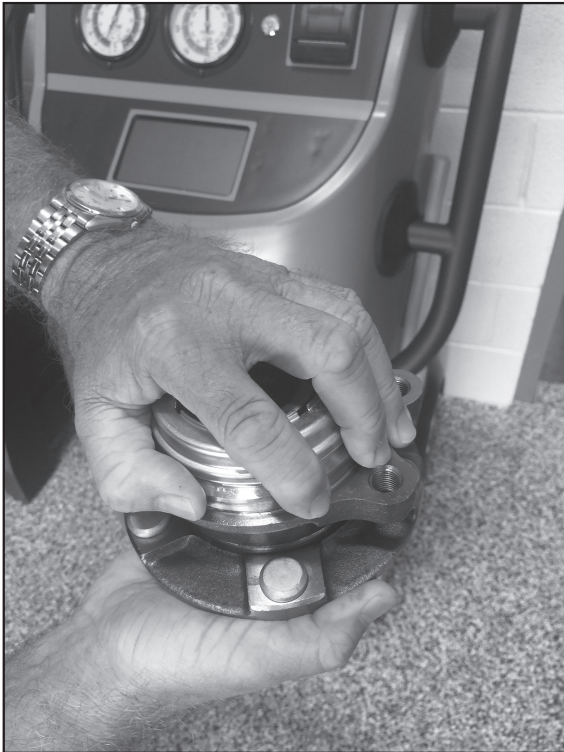
- 5) Hub bearing damage resulting from a wreck or suspension damage may be difficult to pinpoint. Small indentations on the bearing surface created from the impact can promote bearing noise. Diagnosing this condition may require removing the hub bearing assembly from the vehicle for a hands-on inspection. While holding the hub bearing assembly with both hands, rotate the bearing clockwise and counterclockwise while observing for any evidence of roughness (see illustration). A minor roughness or imperfection can promote major noise related symptoms, especially when loaded with the vehicle's weight and while turning.
